# Inspection Report

## Point of View Inspections

537, 539, 541, 543, 545, 547 Maynard Cres.

Faro, YT

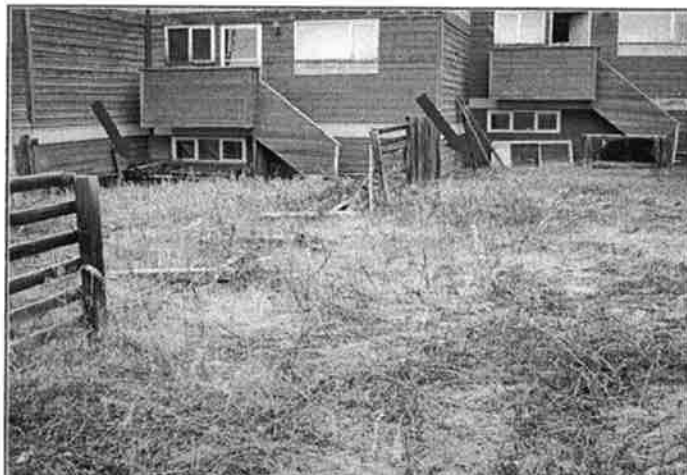
**1) Grading Conditions****PR**

The grading at the rear was sloped towards the building. Signs of soil erosion or depressions were observed. We recommend re-grading to assure all water drains away from the home's foundation. Failure to re-grade low-lying areas at the foundation can cause water seepage under slabs and into the basement / crawlspace.

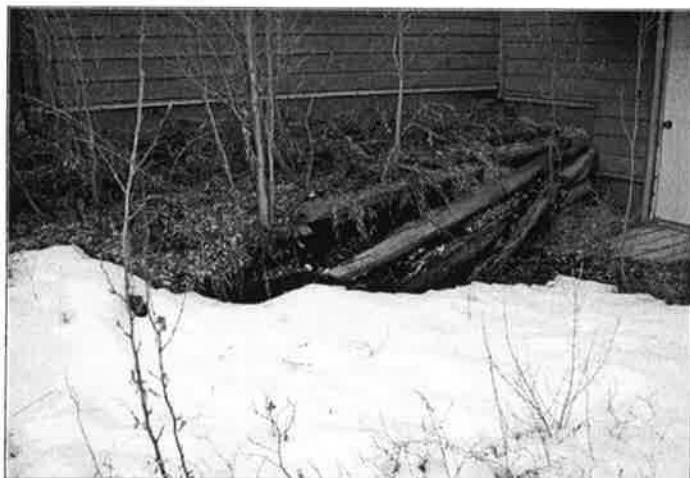
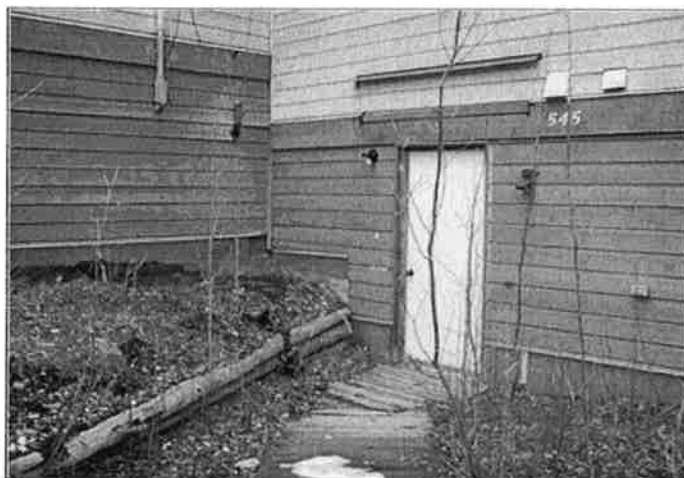
**2) Retaining Wall****NR**

There were small wood retaining walls beside the entrances to some units. Deterioration and / or damage were observed to the retaining walls. Recommend repair as needed.

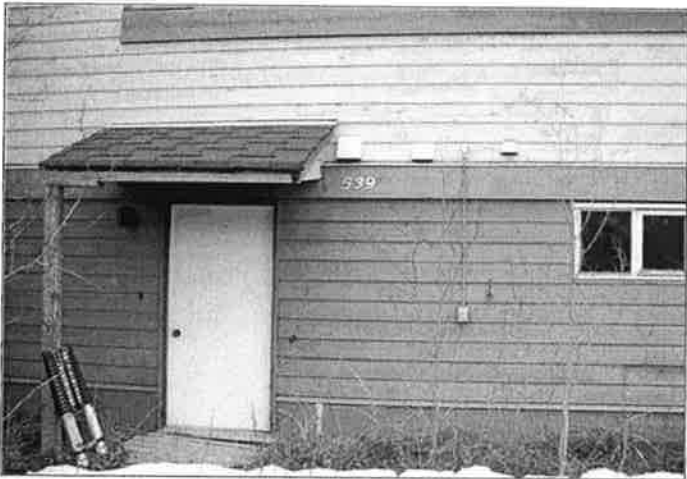
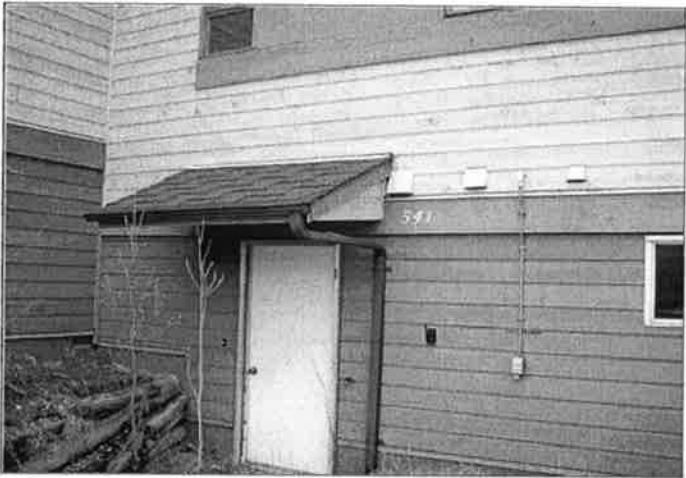
5) Front Entrance Conditions      **FR**      The front entrance is weathered but appeared to be in serviceable condition.

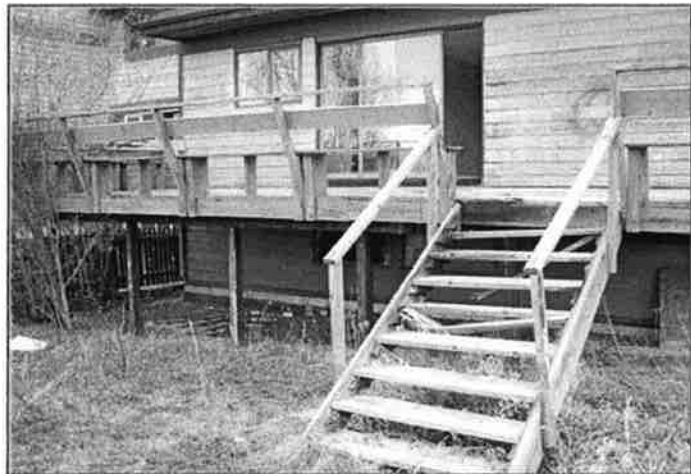
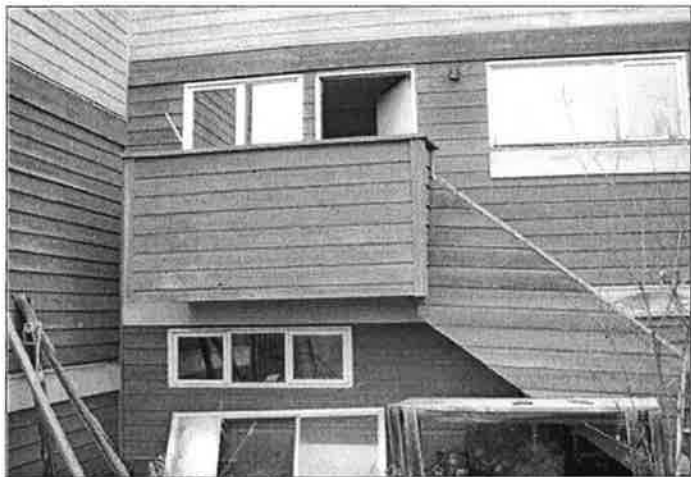
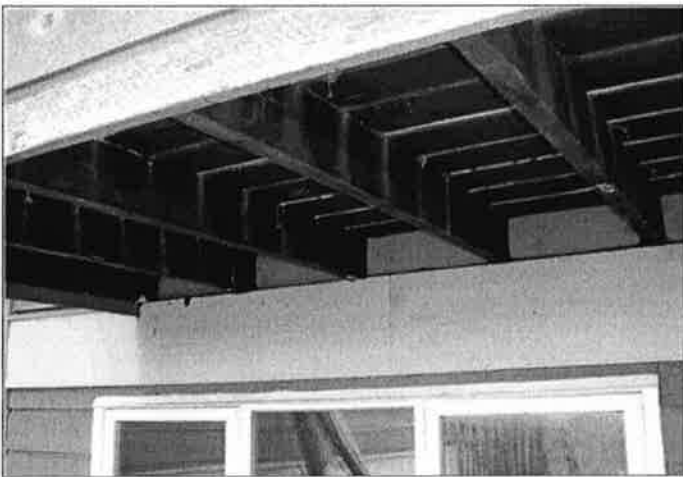
6) Back Entrance Conditions      **NR**      The deck material is wood. The deck on unit 537 had damaged stairs and improper railing. All the deck stairs were damaged or loose. Recommend repair / replacement as needed.

Cost to Replace - Repair      \$20 to 35 per square foot for a deck.

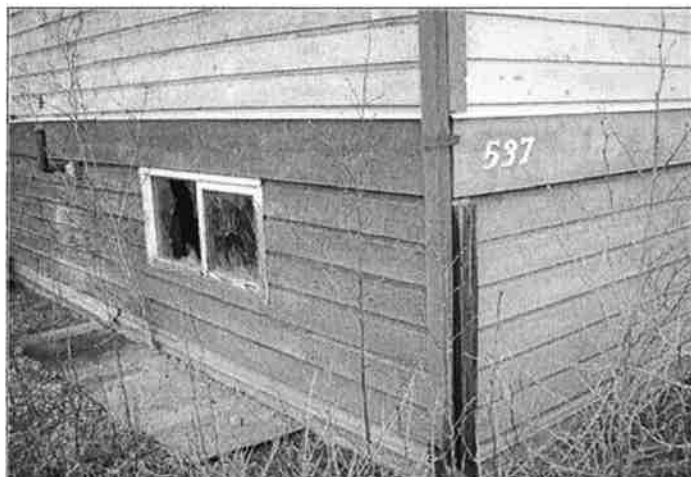
8) Window Conditions

Exterior frame weathering and deterioration was observed. Many windows were broken in unit 537.

\$600 - 1000 each to replace windows.

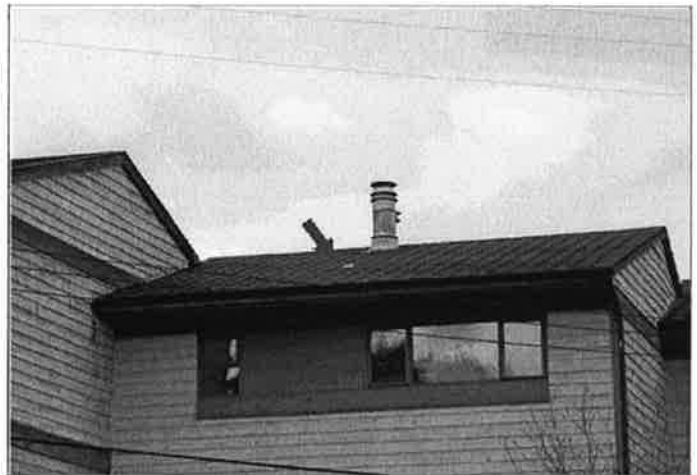
#### 14) Roof Condition

Damaged or missing shingles were observed. The roof covering shows normal wear for its age and is nearing the end of its useful life expectancy. Recommend further evaluation and repair as needed by a qualified / licensed contractor.

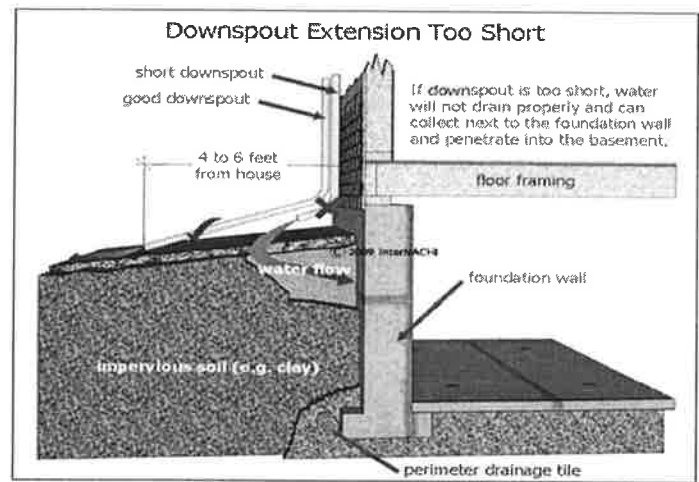
The gutter system appeared to be in serviceable condition at the time of the inspection. Recommend gutter downspouts be

extended and routed away from the building for proper drainage. Water seepage into crawl spaces, basements and under foundations can be caused by inadequate removal of rainwater from the perimeter of the house.

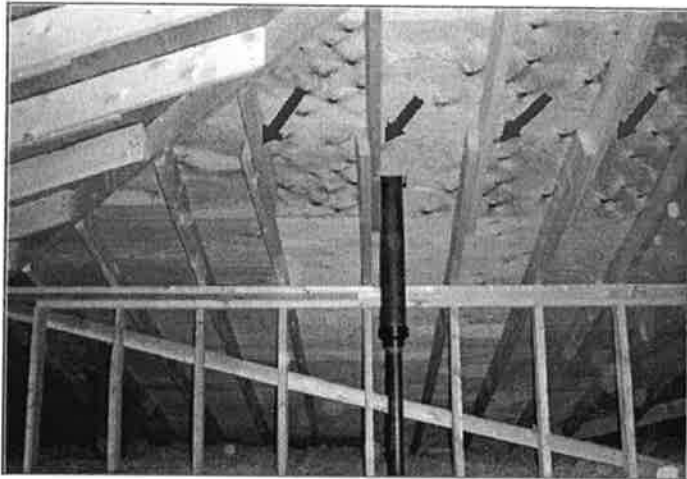
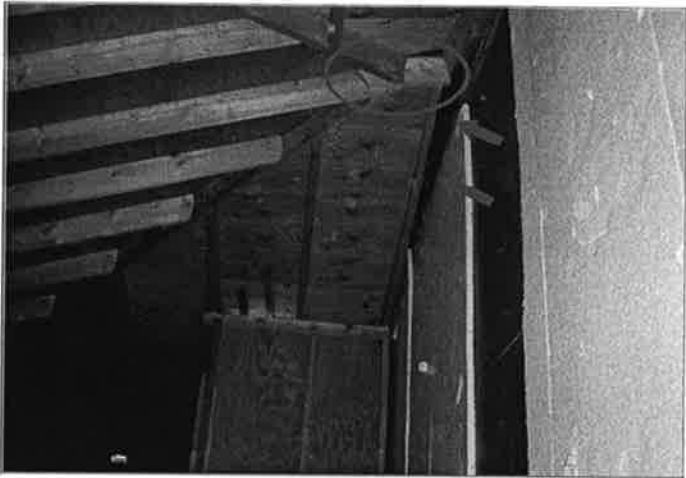
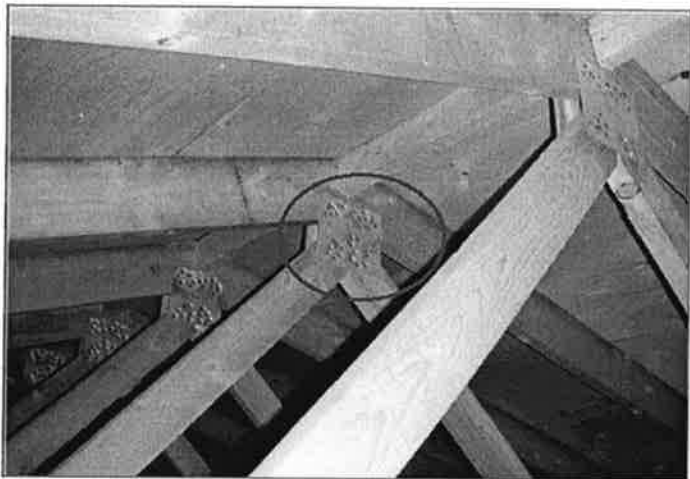
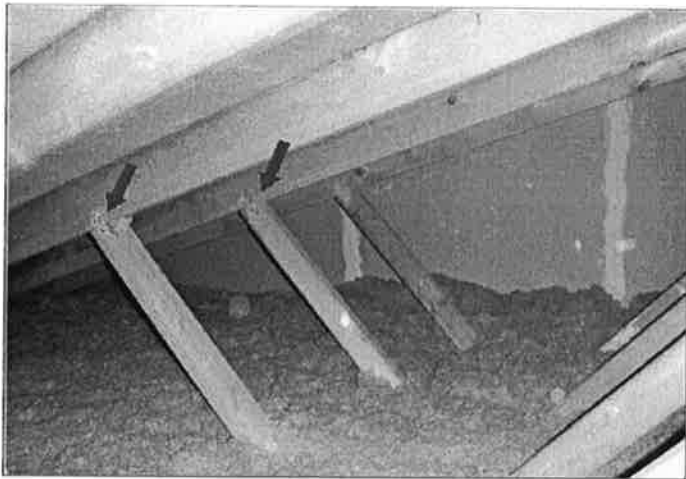
19) Roof Frame Conditions

**PR** The rafters in unit 537 are not continuous. There is a connection made halfway through the span that is not supported by a bearing point. The hip rafters are 2x6, normally hip rafters are one dimension larger(2x8) than the common rafters. The hip rafters are connected to a small block at the top. This connection does not appear to be structurally adequate. It appears that the rafters connecting unit 537 and 539 may be pulling away from each other. This may be caused by the building settling which will be discussed later in the report.

connections do not appear to be done to current standards. At the time of inspection no structural deficiencies were noticed in the trusses but this does not guarantee the future integrity of the roof. Recommend further evaluation from a structural engineer.

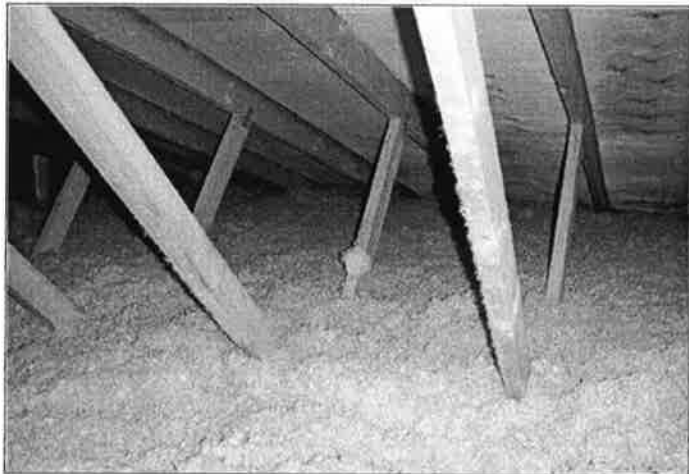
**GD** The attic insulation is R-50+ which is acceptable with current standards.

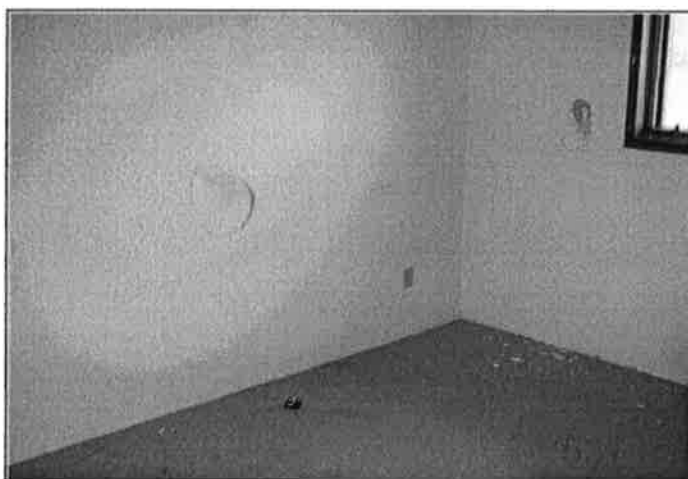
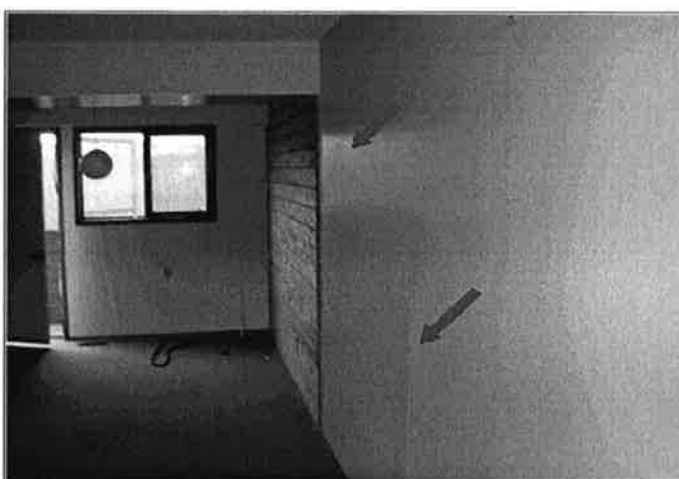
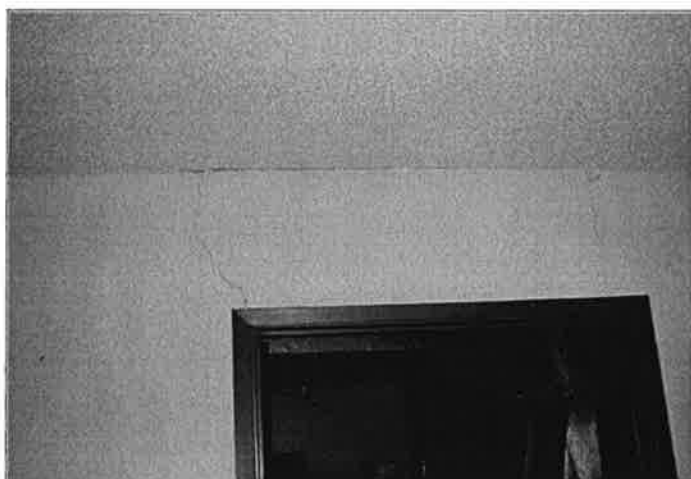
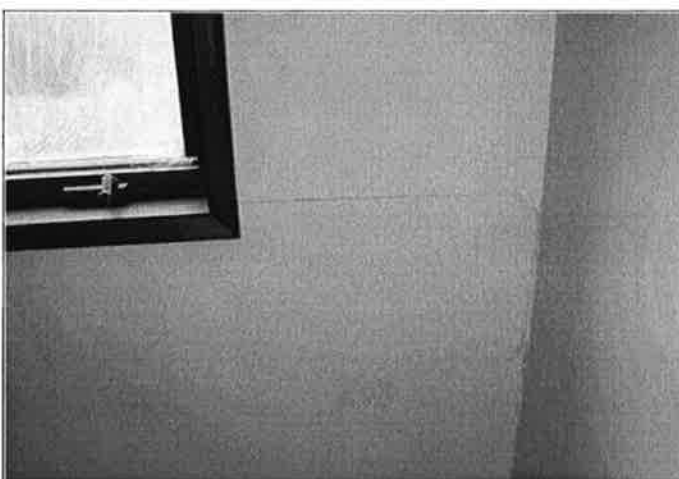
**5 Interiors****Walls - Ceilings - Floors****23) Wall Conditions****PR**

The interior walls are painted drywall. The interior walls were damaged in unit 537. There were settlement cracks throughout each unit and specifically where the units join each other. There is clear evidence of differential settlement. Recommend further evaluation and repair as needed by a qualified / licensed contractor.

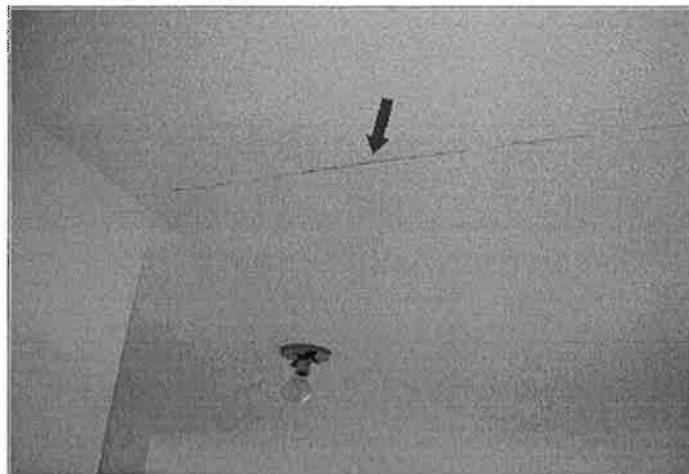
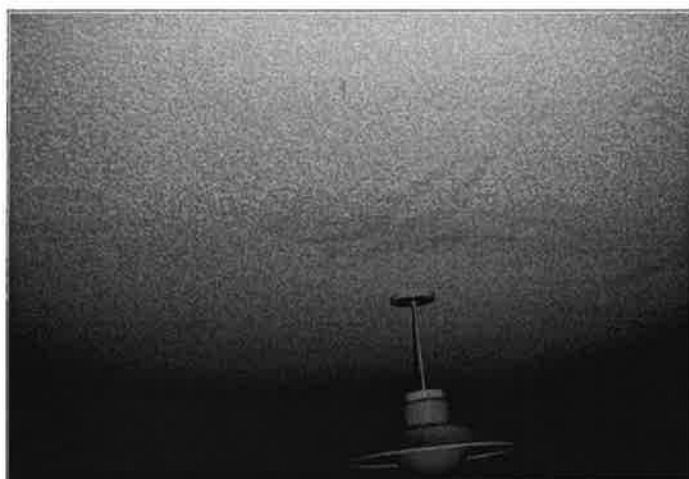
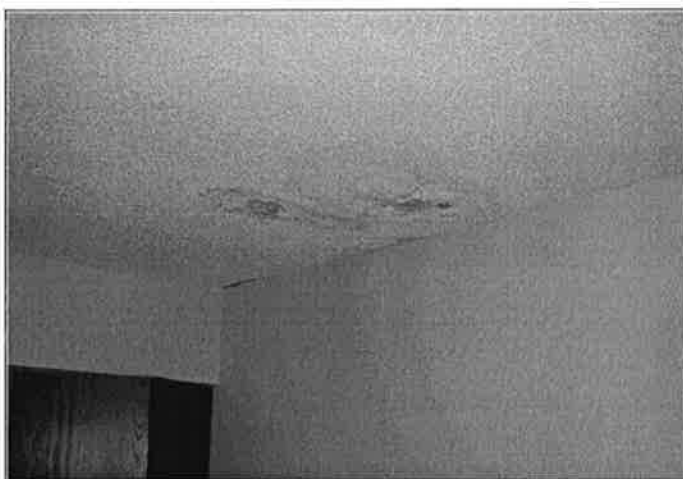
**24) Ceiling Conditions****PR**

The interior ceilings are drywall with texture. There are numerous settlement cracks throughout the building. There was evidence of roof leaks in units 543 and 547. There was water staining in the basement ceiling below the kitchen in unit 541. This may have been caused from a plumbing leak.

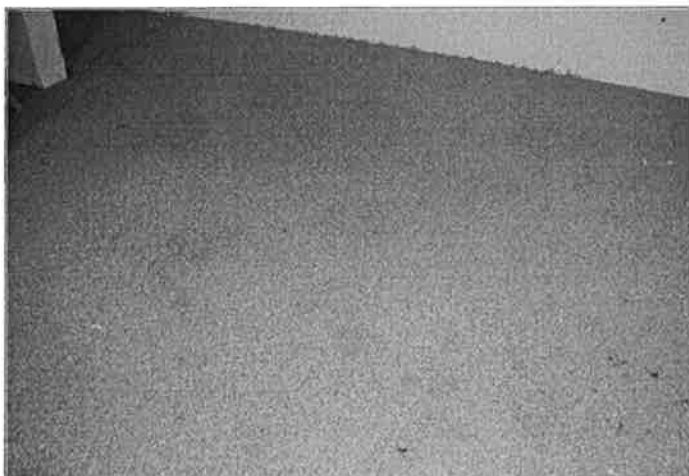
The interior floor material is carpet. The general condition of the visible and accessible portions of the floors appeared to be in serviceable condition at the time of the inspection. Carpet was removed from unit 539.

Cost to Repair - Replace      \$5 - 10 / sq.ft. to replace carpet.  
\$6 - 12 per sq./ft. for laminate flooring.

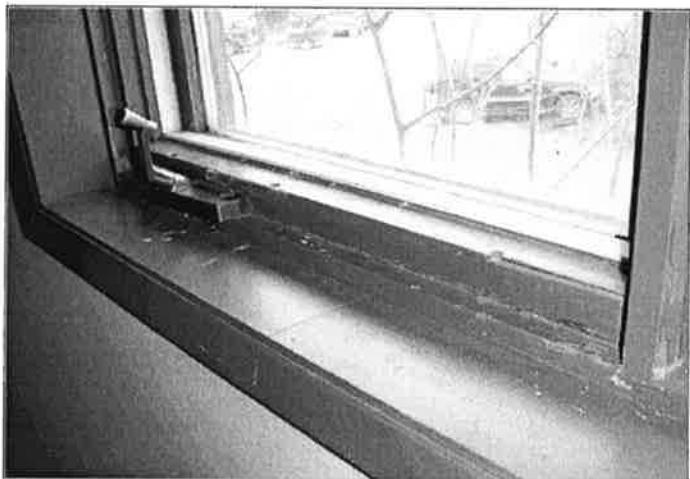
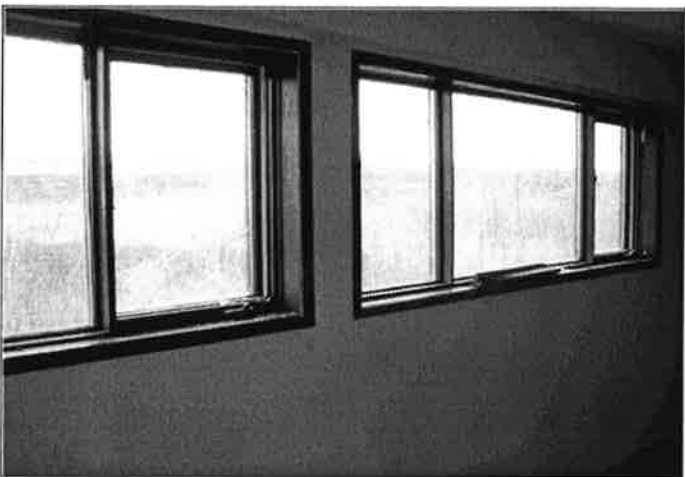
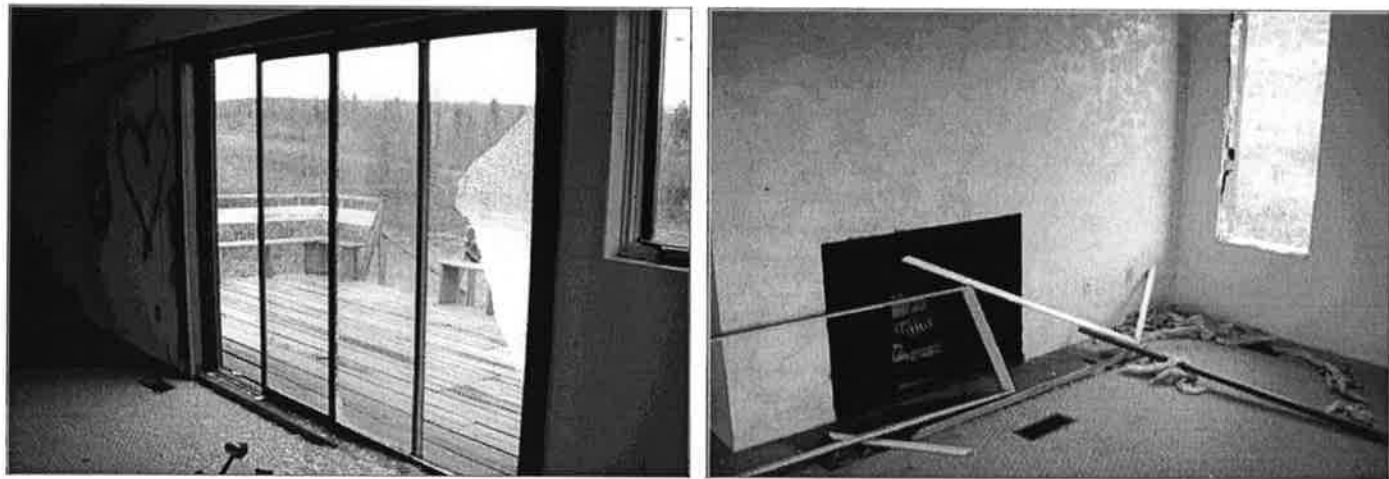
28) Interior Window Conditions      **NR**      The sample of windows tested were operational at the time of the inspection. Many windows throughout unit 537 were broken. The paint was deteriorated on the window frames. Recommend repair as needed.

Cost to Repair - Replace      \$600 - 1000 to replace window.  
\$150 - 200 to replace interior doors.

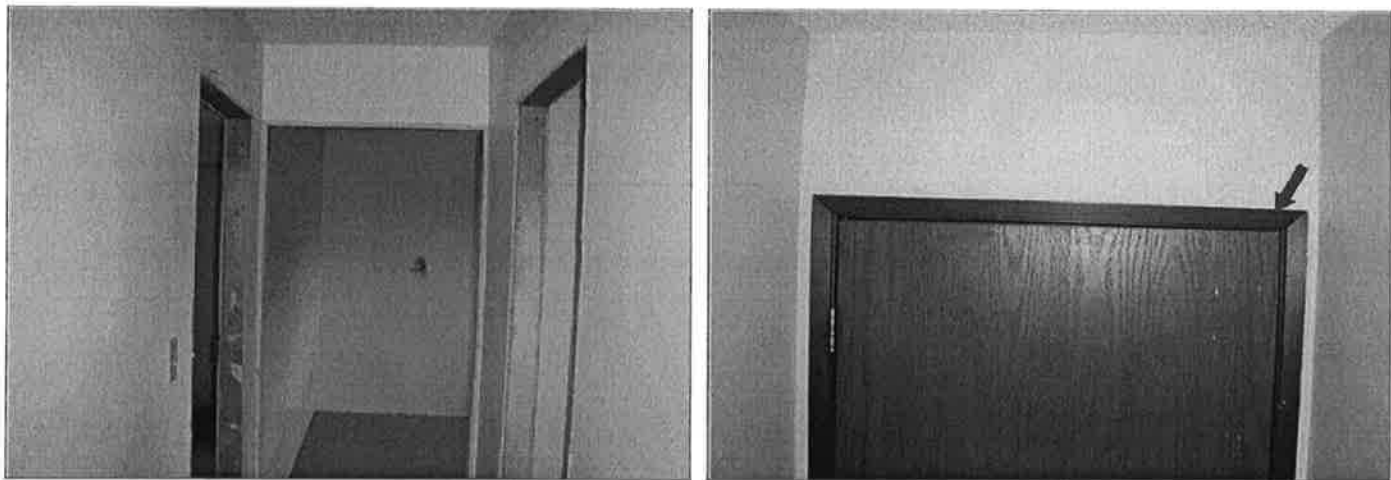
29) Interior Door Conditions      **NR**      The interior doors appeared to be in serviceable condition at the time of the inspection. Doors were missing in units 537 and 541. Some of the doors were stiff when closing. This is caused by the differential settlement in the foundation.

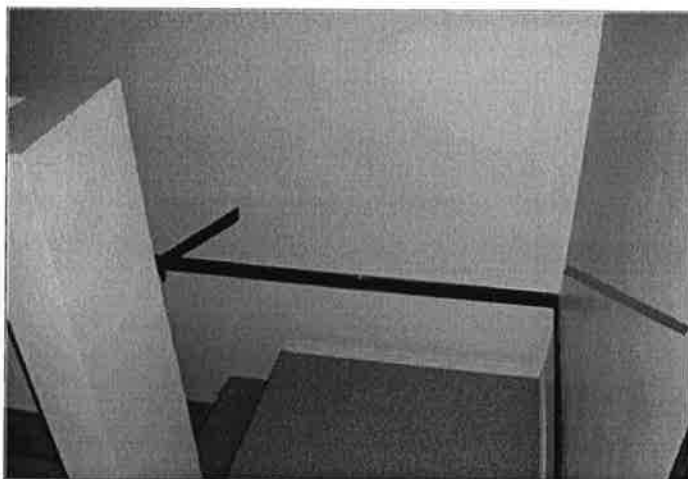
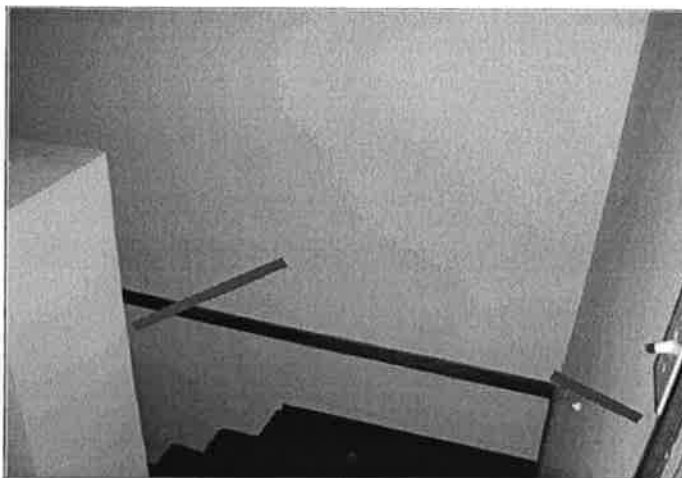
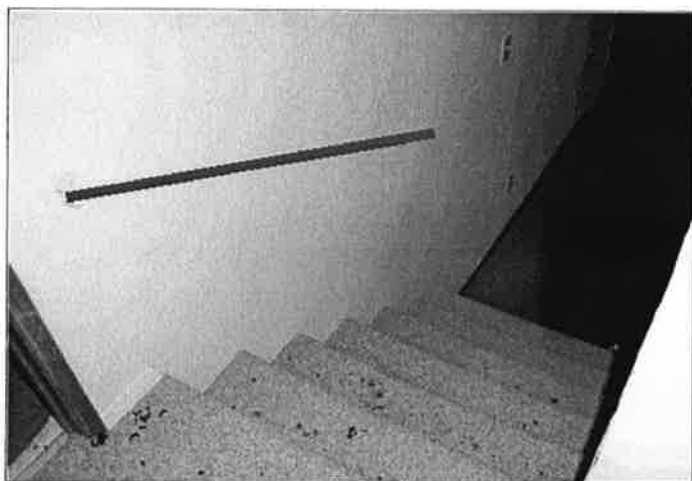
**34) Railing Conditions****US**

The stair railing was missing or not installed in some units. Recommend installation of railings as a safety measure.

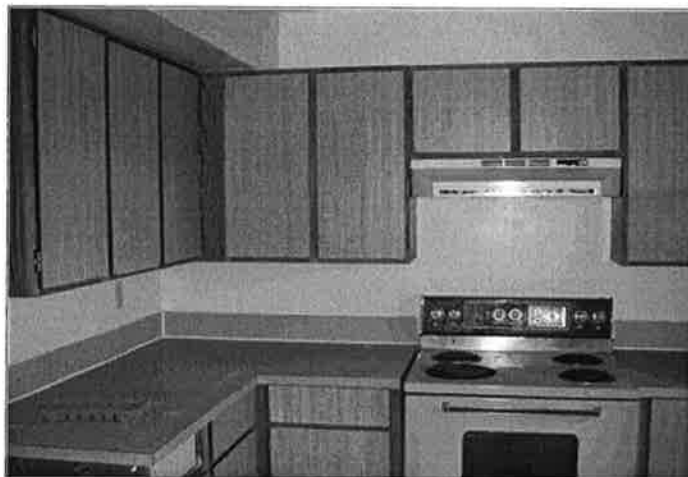
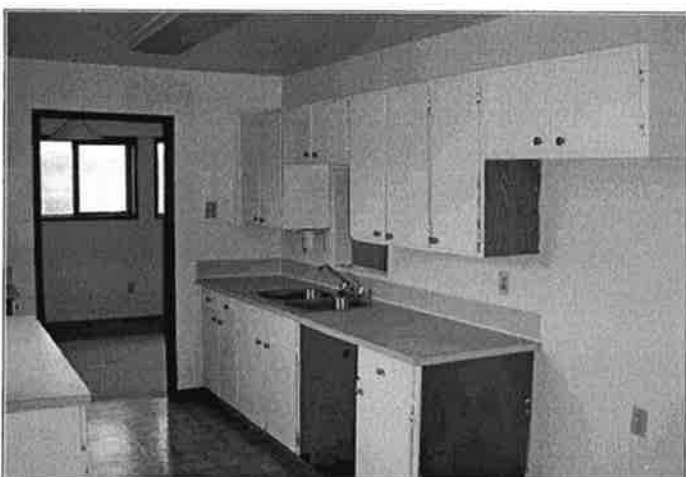
**44) Cabinet Conditions****FR**

The cabinets are made of particle board with laminate doors. Some of the cabinet doors / drawers were missing. The cabinets were functional at the time of inspection. The counter and cabinets appear to be salvageable in all units.

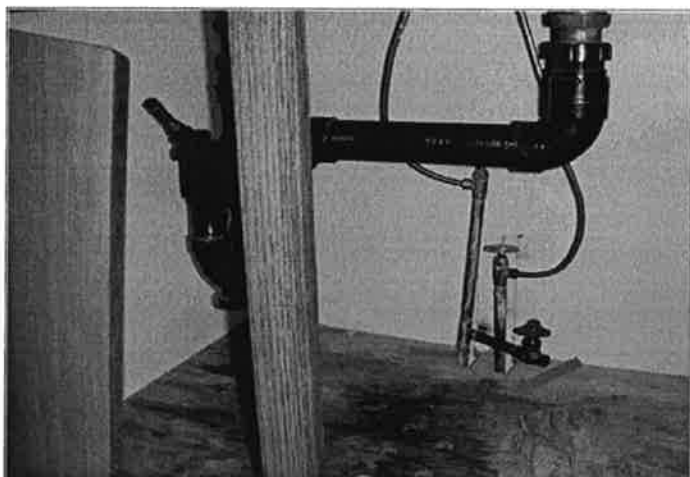
**45) Sink Plumbing Conditions****PR**

The kitchen sink plumbing appeared to be in serviceable condition at the time of the inspection. There is evidence of a previous water leak in unit 543.

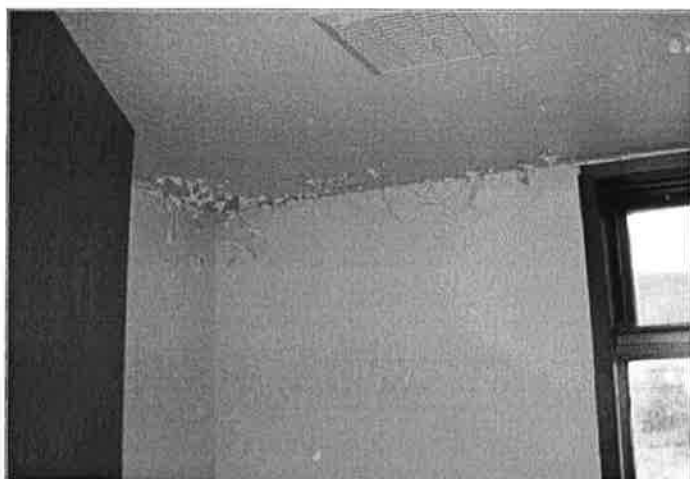
The ceiling material is drywall with texture. Some paint was peeling in unit 543.

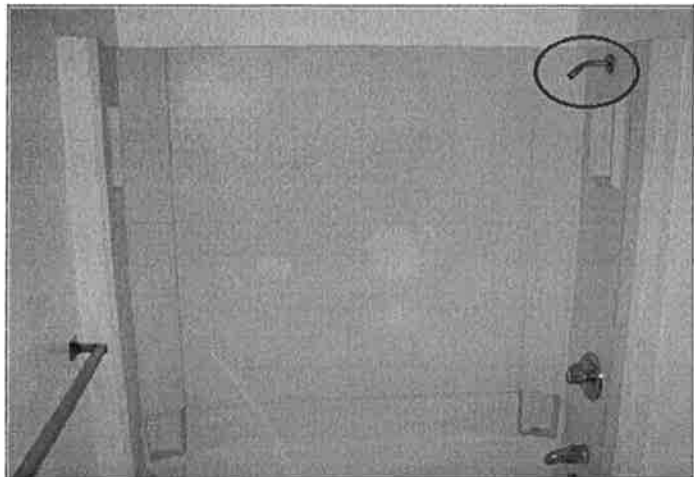
**FR** The tub/shower is a one piece fiberglass insert. The shower head was missing from unit 537.

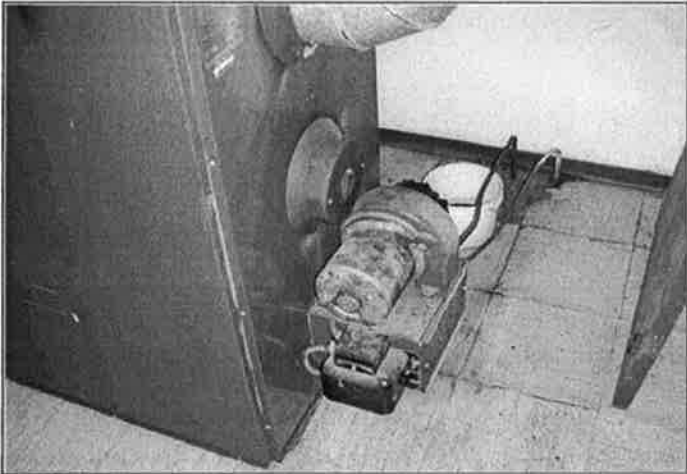
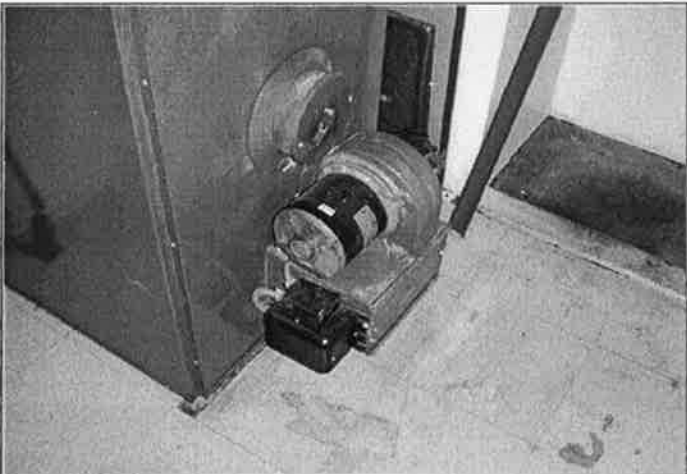
Heating	
Location of Unit	The heating systems are in the basement.
Heating Type	The heating type is a forced air furnace.
Energy Source	The energy source is oil.
67) Unit Conditions	<div>NR</div> At the time of inspection, the fuel was off. Inspection of appliances that are shut down is not performed, therefore our review is very limited in scope. We suggest that the client obtain a full and complete inspection from a qualified contractor to determine if any parts are salvageable.
<div>

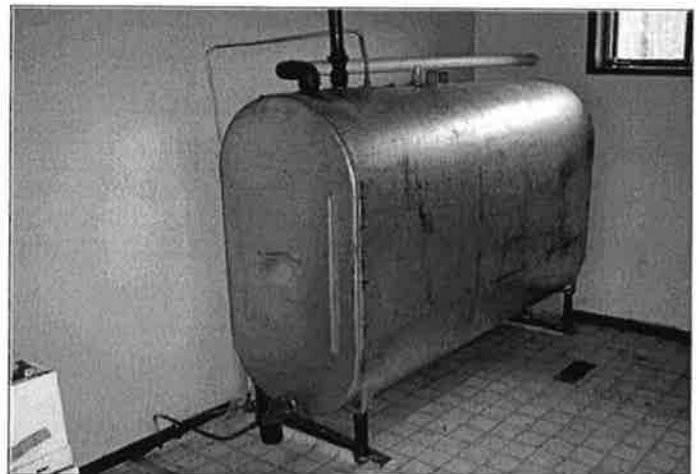
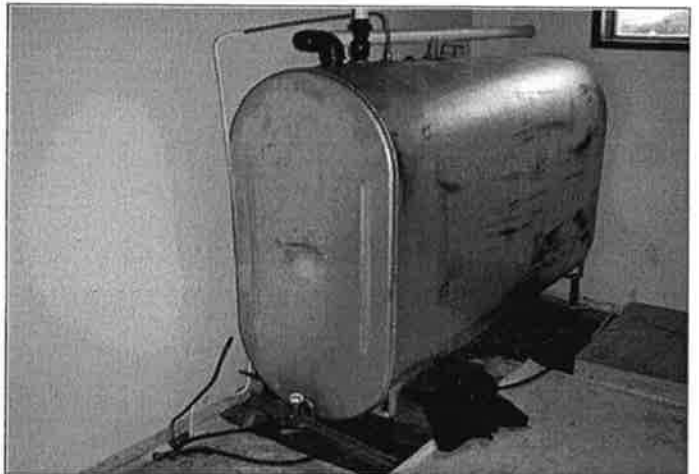
The fuel tanks are single wall. The oil tanks are inside the house. Most insurance companies will not insure a house with indoor fuel tanks. The oil tanks will have to be removed and replaced.

<b>Capacity</b>	1000L
<b>Cost to Replace</b>	\$3000 - 5000 each.

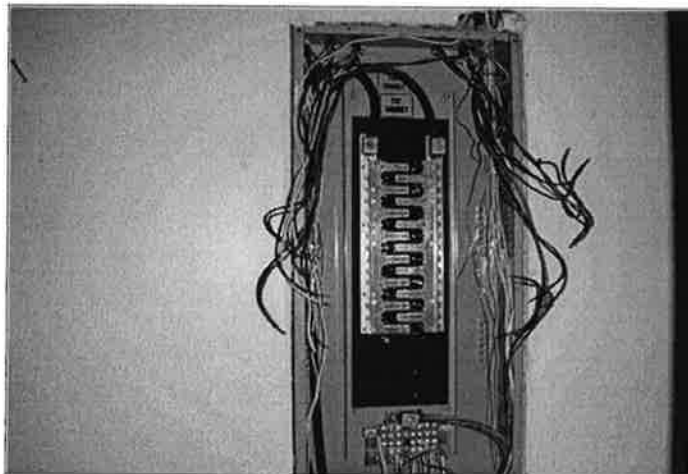
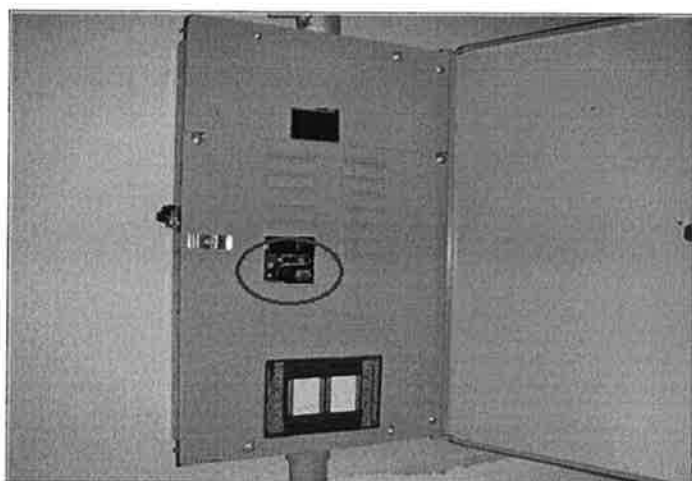
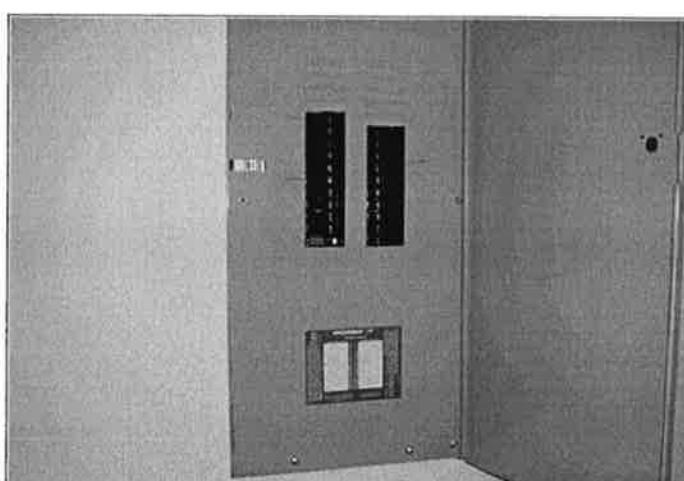
**75) Electrical Panel Conditions**

The breakers were removed from unit 537. There was no main shut-off breaker on the panels. The panel was missing covers where breakers were not installed. Recommend installation of standard covers for safety. Recommend further evaluation from a licensed electrician.

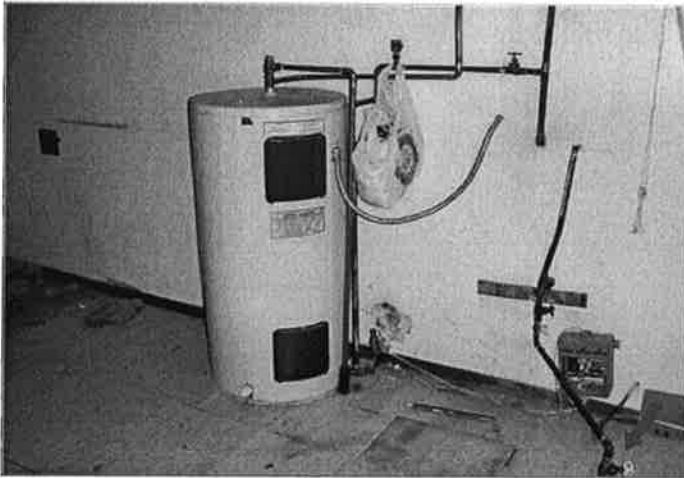
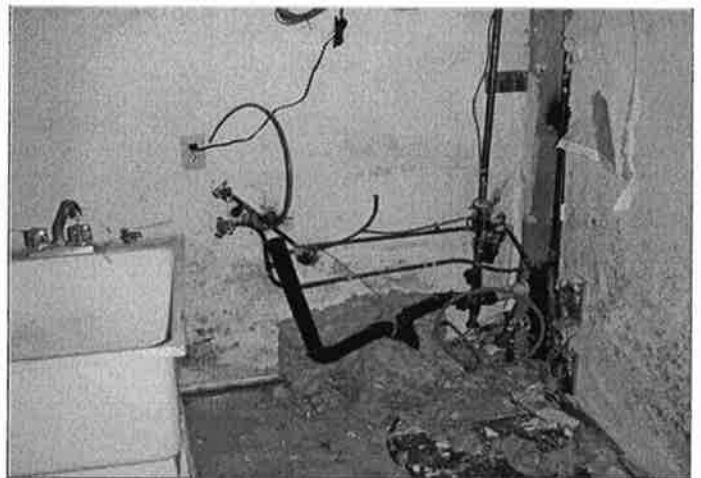
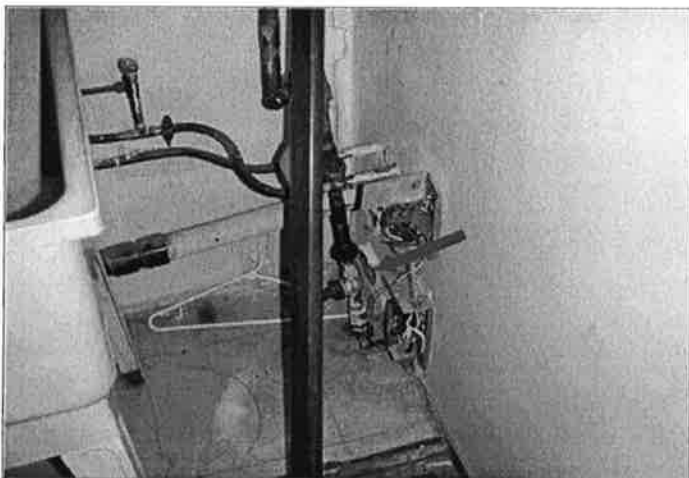
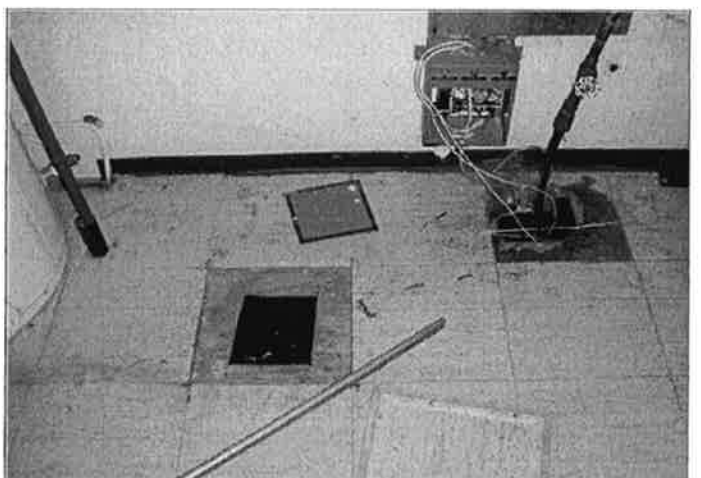
**76) Main Line & Valve Conditions**

The visible portions of the main lines had corrosion observed at the accessible areas. There is evidence that the main lines may have leaked. Some of the plumbing lines have been disconnected. Recommend further evaluation from a licensed plumber.

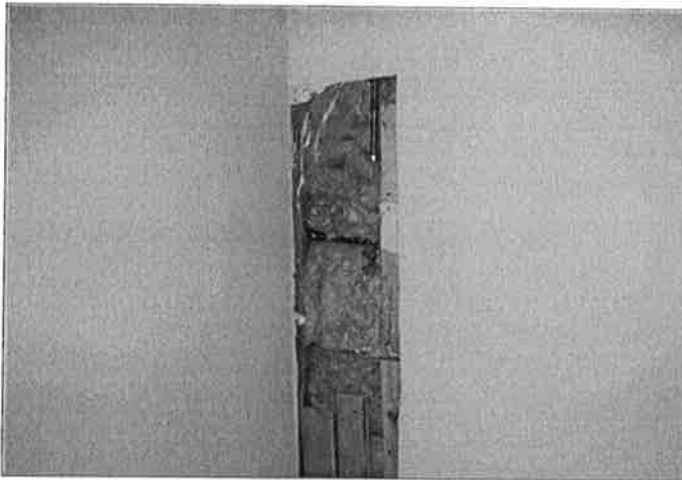
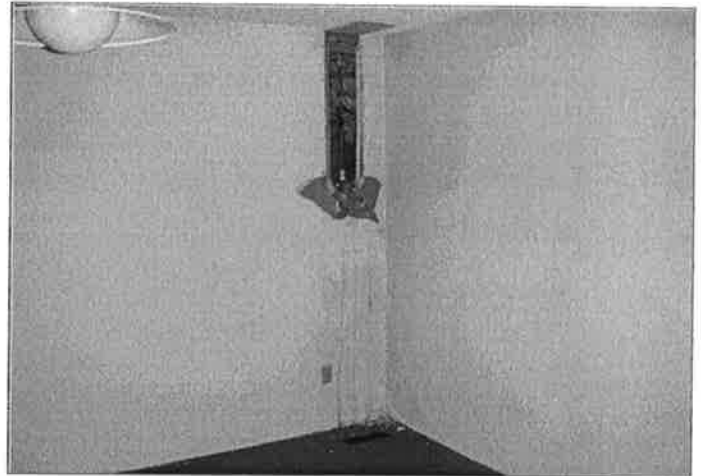
The visible portions of the supply lines appeared to be in serviceable condition at the time of inspection. All of the supply lines were not fully visible or accessible at the time of the inspection. The visible portions of the supply lines had minor corrosion observed in some areas. Some of the walls were opened to access plumbing valves that may have froze. Recommend further evaluation.

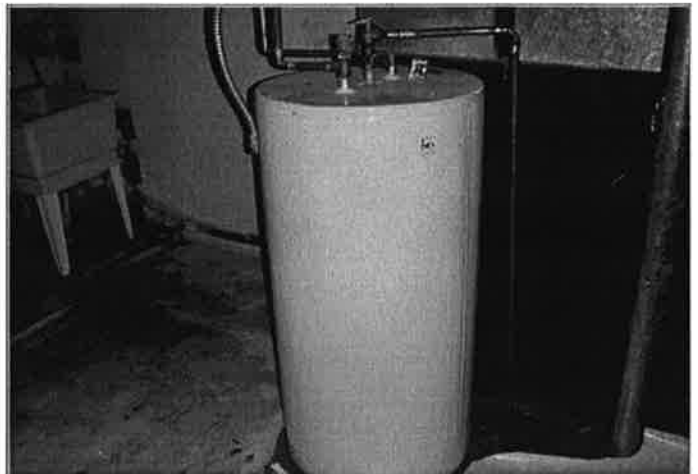
**NR** The water heaters were past their life expectancy. Some of them may be salvageable but will need to be replaced soon. Recommend further evaluation from a licensed plumber.

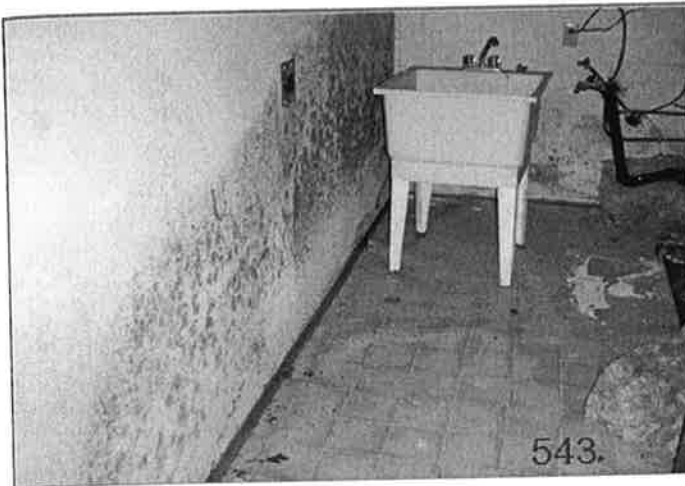
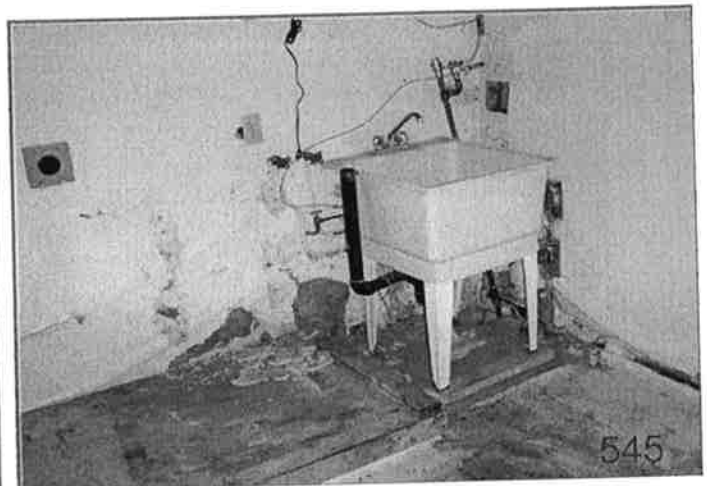
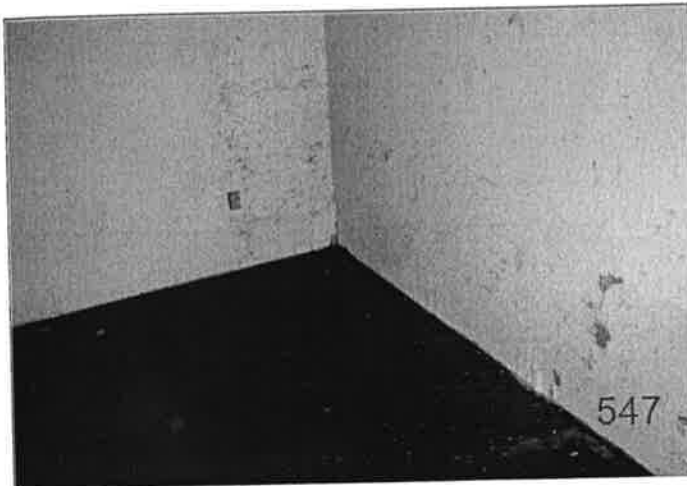
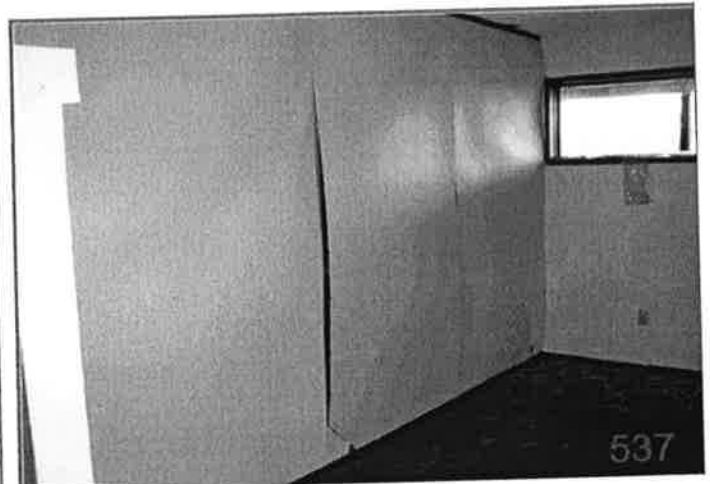
The basement walls are painted drywall. There was a large amount of surface mold on the basement walls in units 543, 545 and 547. No moisture was detected when tested with a moisture meter except 547 where there is an active water leak. The drywall should be removed from these units by a level 3 mold remediation. More about mold remediation will be included in the final report. There is damaged wall board in unit 537.

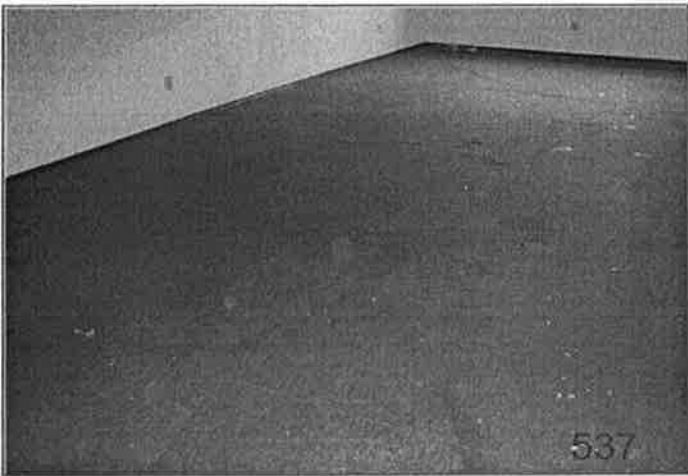
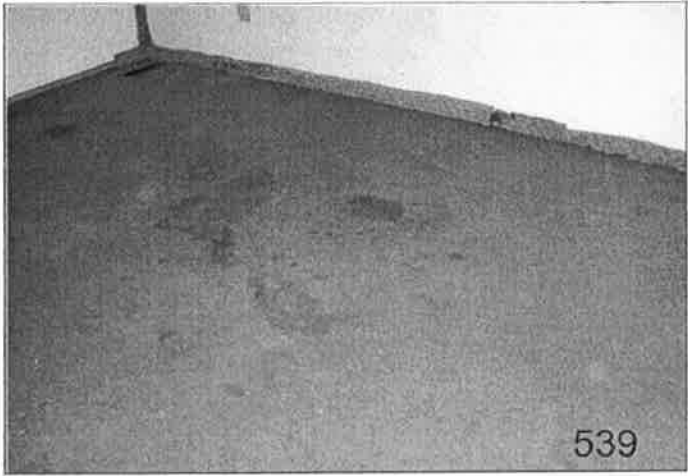
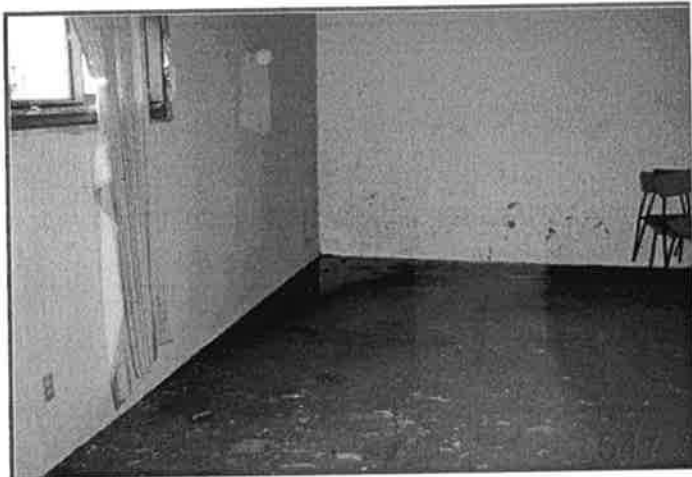
The basement floor material is carpet and plywood. There are many stains on the carpets throughout the building. Unit 545 had extensive water damage to the wall and floor behind the laundry sink from an apparent water leak. Unit 547 has an active water leak, the flooring is soaked and there is water pooling on the rear of the unit. The carpets do not appear to be salvageable. The floors in the basements are sloped to the west, this is especially noticeable in unit 539.

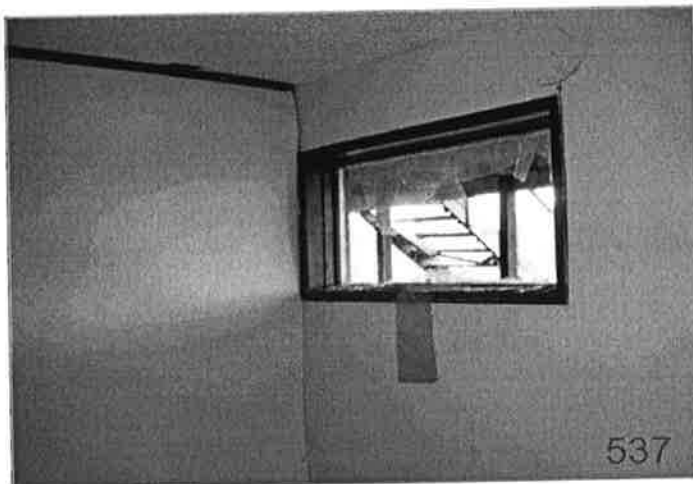
The windows in unit 537 are broken.

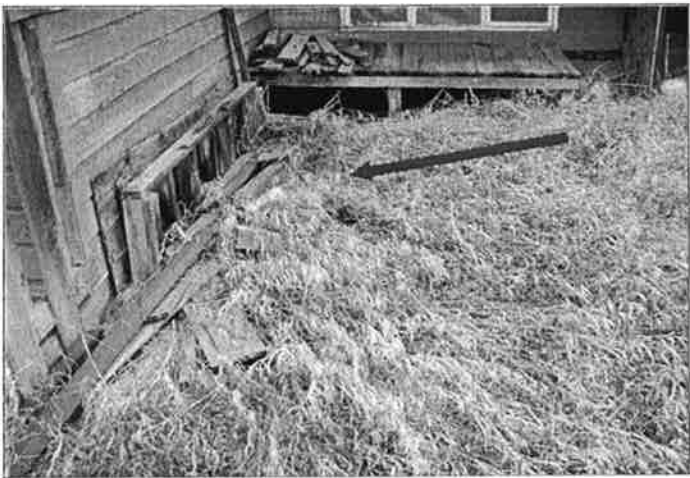
91) Foundation Condition      **NR**      The foundation of this building is unstable. There is numerous signs of differential settlement. This means the building has sank at uneven rates causing structural shifting and damage. The signs show the building has sank to the rear and to the right (south and west). Soil depressions at the rear of the building suggest that the ground is unstable. Due to the conditions observed I do not believe the building is salvageable. Recommend further evaluation from a structural engineer and / or foundation specialist. The building may be salvageable but the costs would most likely be beyond its worth.
