# Inspection Report

## Point of View Inspections

537, 539, 541, 543, 545, 547 Maynard Cres.

Faro, YT

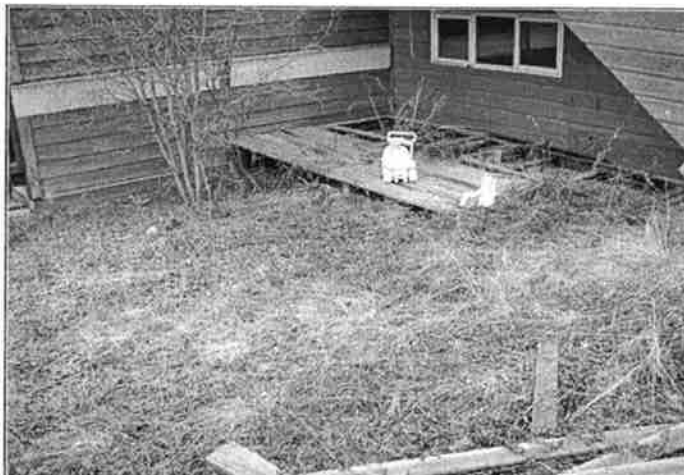
**1) Grading Conditions****PR**

The grading at the rear was sloped towards the building. Signs of soil erosion or depressions were observed. We recommend re-grading to assure all water drains away from the home's foundation. Failure to re-grade low-lying areas at the foundation can cause water seepage under slabs and into the basement / crawlspace.

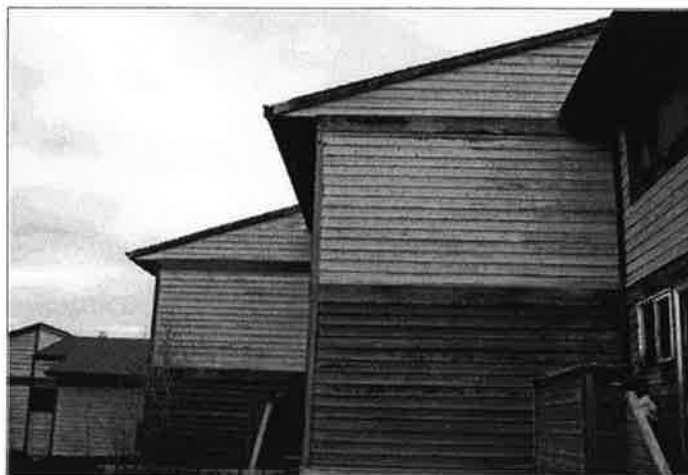
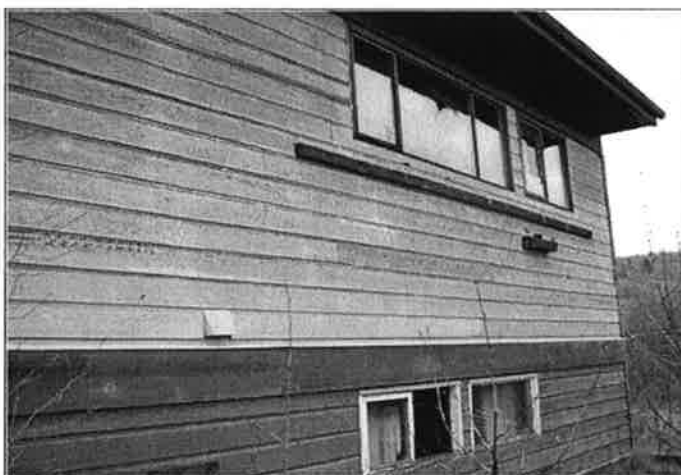
The exterior siding is weathered but appears to be salvageable. Wood siding should be painted / stained every 5 -7 years.

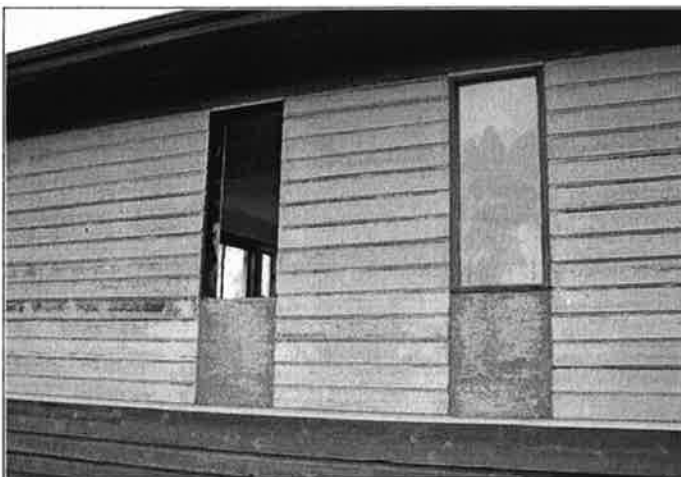
8) Window Conditions

Exterior frame weathering and deterioration was observed. Many windows were broken in unit 537.

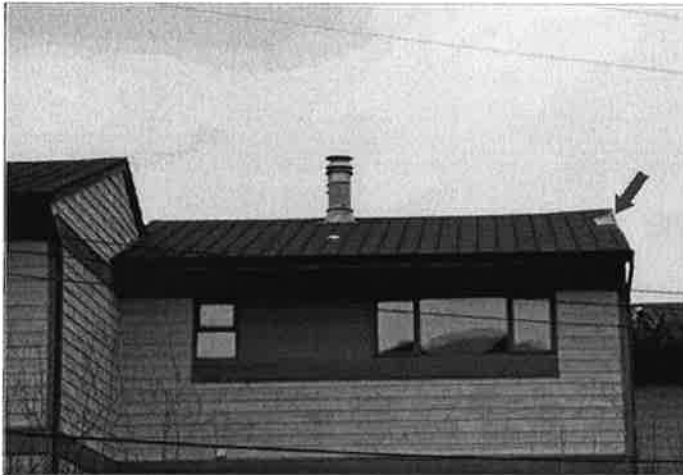
#### 14) Roof Condition

Damaged or missing shingles were observed. The roof covering shows normal wear for its age and is nearing the end of its useful life expectancy. Recommend further evaluation and repair as needed by a qualified / licensed contractor.

Needs immediate repair.

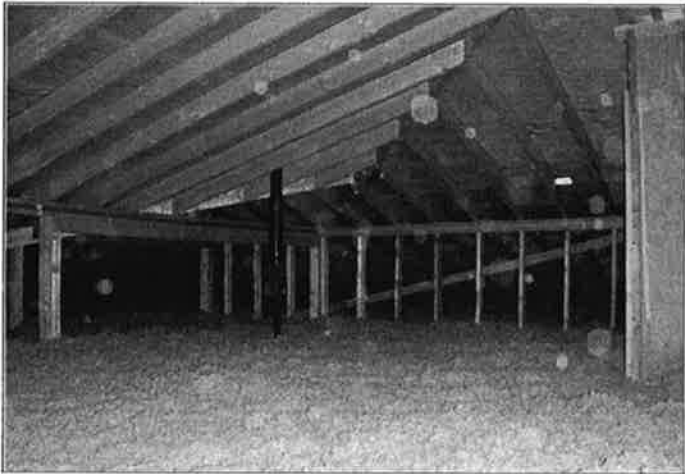
**GD** The attic insulation is R-50+ which is acceptable with current standards.

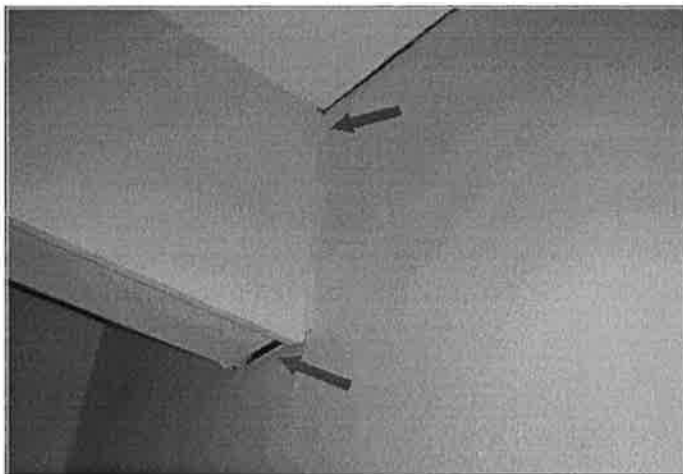
The interior ceilings are drywall with texture. There are numerous settlement cracks throughout the building. There was evidence of roof leaks in units 543 and 547. There was water staining in the basement ceiling below the kitchen in unit 541. This may have been caused from a plumbing leak.

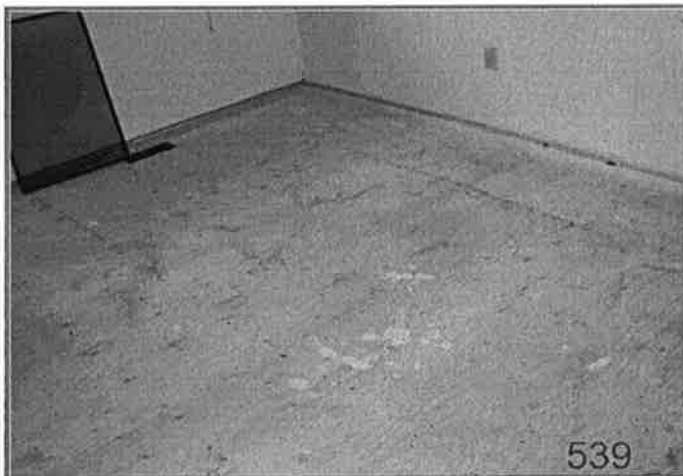
The interior floor material is carpet. The general condition of the visible and accessible portions of the floors appeared to be in serviceable condition at the time of the inspection. Carpet was removed from unit 539.

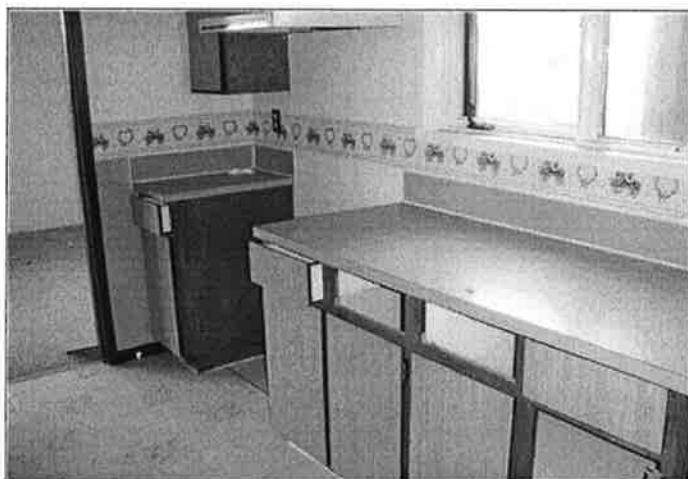
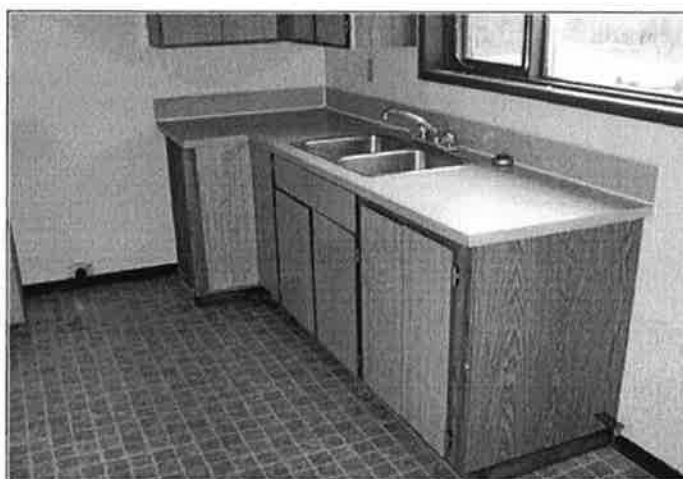
#### 37) Floor Conditions

The kitchen floor material is linoleum. The general condition of the visible and accessible portions of the floors appeared to be in serviceable condition at the time of the inspection.

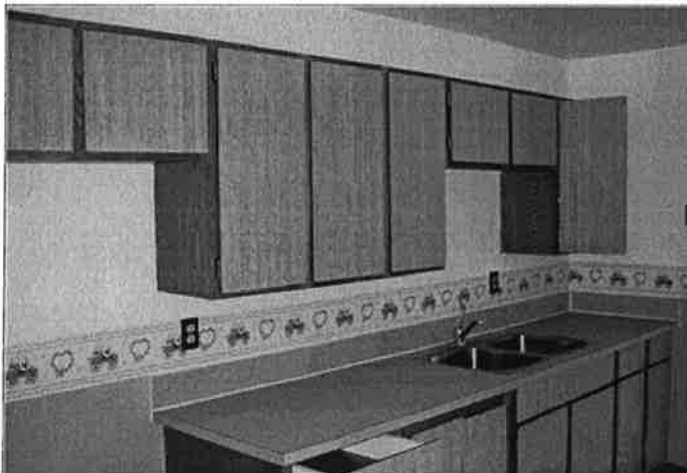
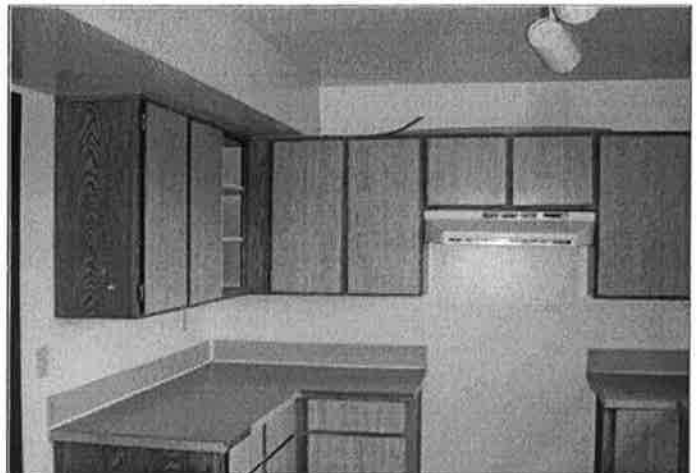
The kitchen counters were made of laminate. The kitchen counters appeared to be in serviceable condition at the time of inspection.

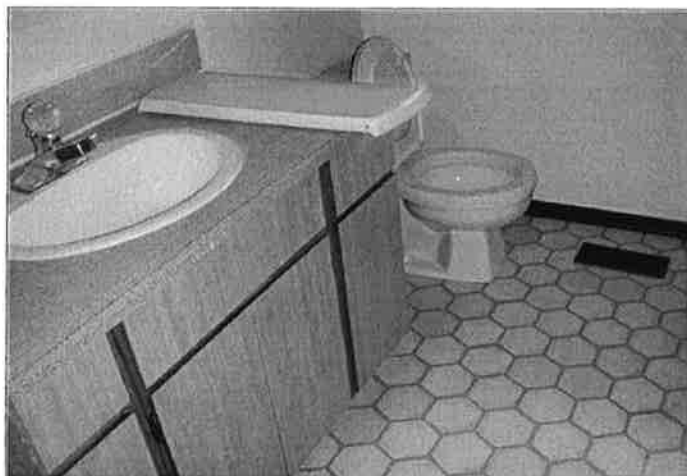
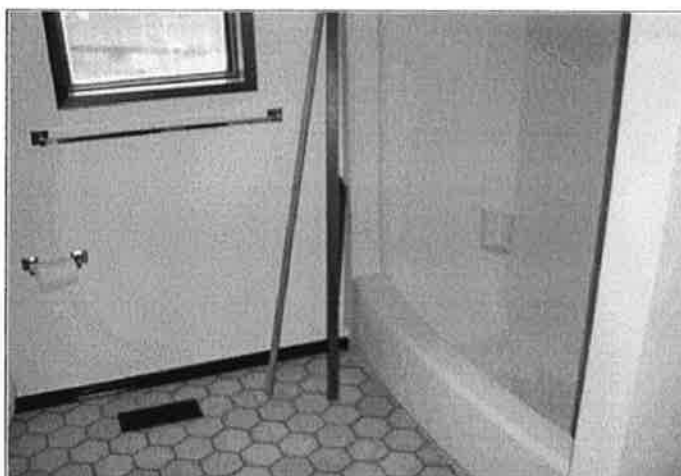
The interior walls are painted drywall. The general condition of the visible and accessible interior walls appeared serviceable at the time of the inspection.

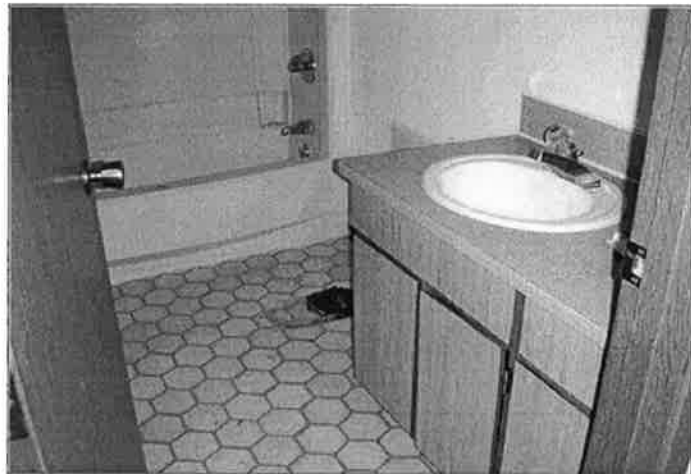
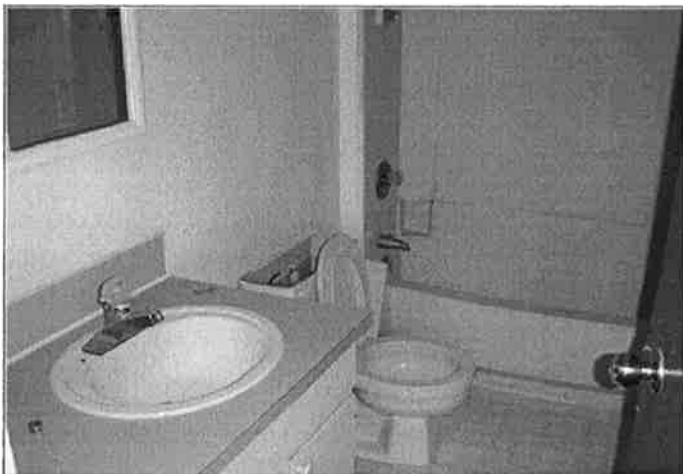
The counter material is laminate. The cabinet material is laminate. The visible portion bathroom counters appeared to be in serviceable condition at the time of the inspection.

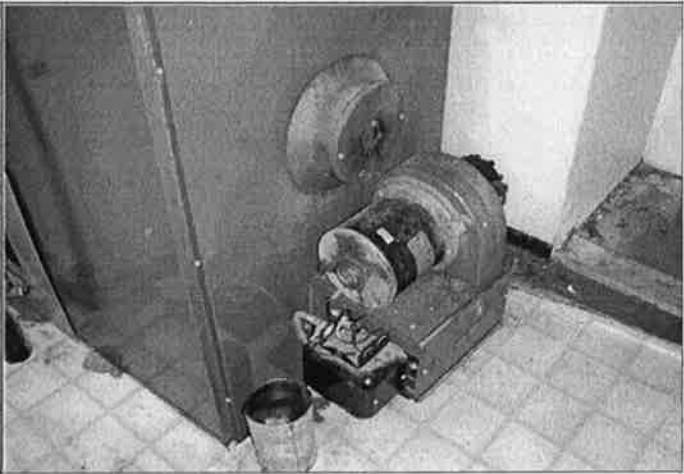
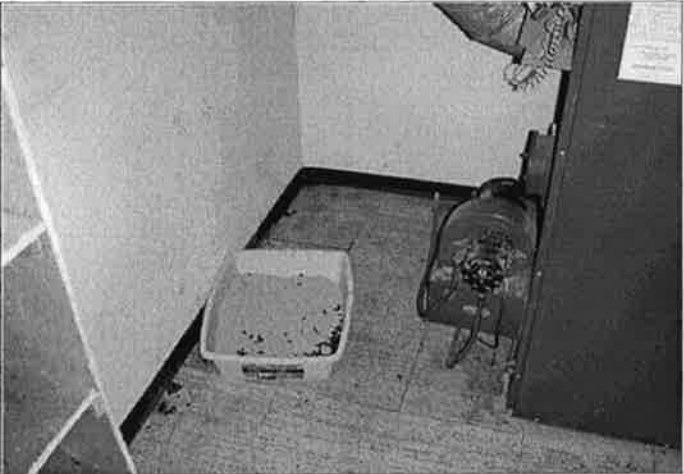
Heating	
Location of Unit	The heating systems are in the basement.
Heating Type	The heating type is a forced air furnace.
Energy Source	The energy source is oil.
67) Unit Conditions	<div>NR</div> At the time of inspection, the fuel was off. Inspection of appliances that are shut down is not performed, therefore our review is very limited in scope. We suggest that the client obtain a full and complete inspection from a qualified contractor to determine if any parts are salvageable.
<div>

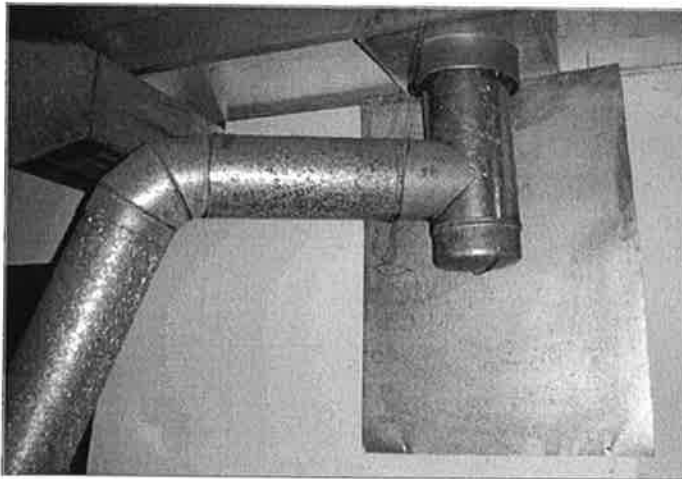
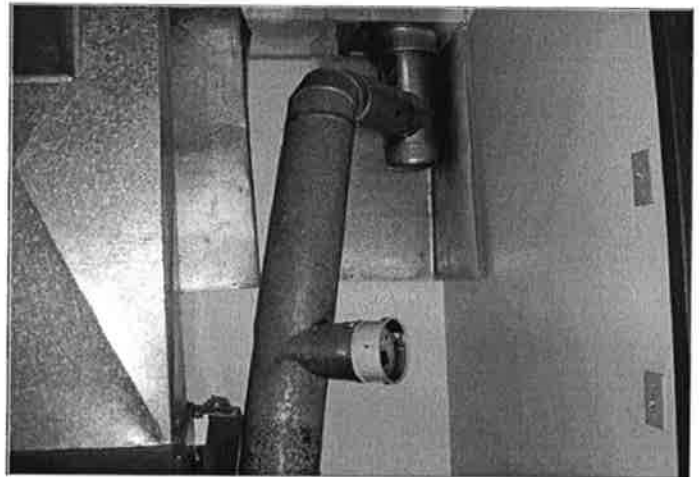
The visible and accessible portion of the venting flue appeared to be in serviceable condition at the time of the inspection.

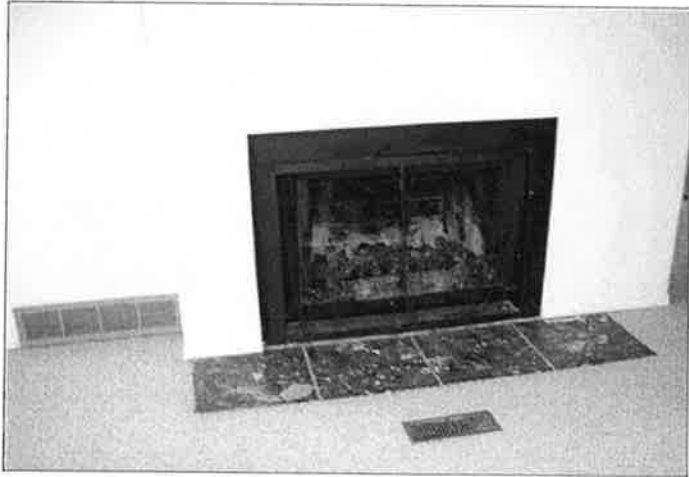
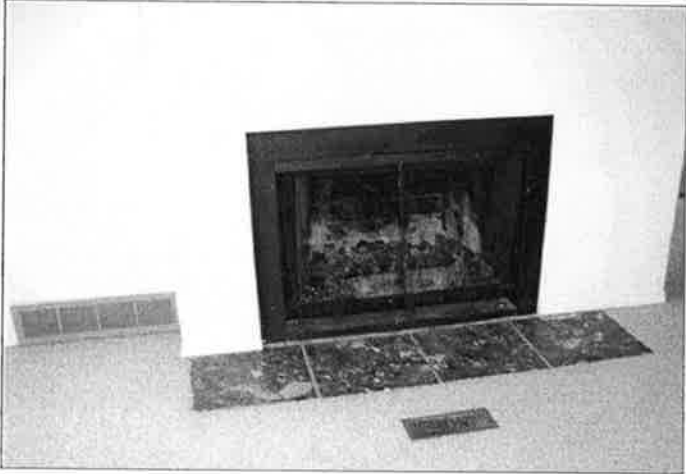
The visible and accessible area of the fireplace appeared to be in serviceable condition at the time of the inspection. The fireplace was visually inspected only. Client is advised to consult with owners manual or manufacturer for proper usage and safety related concerns. I would also recommend having a more thorough inspection / sweep by a certified W.E.T.T. professional.

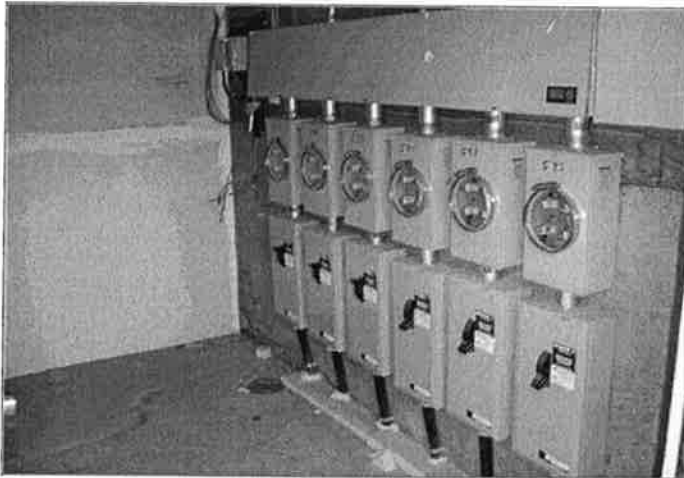
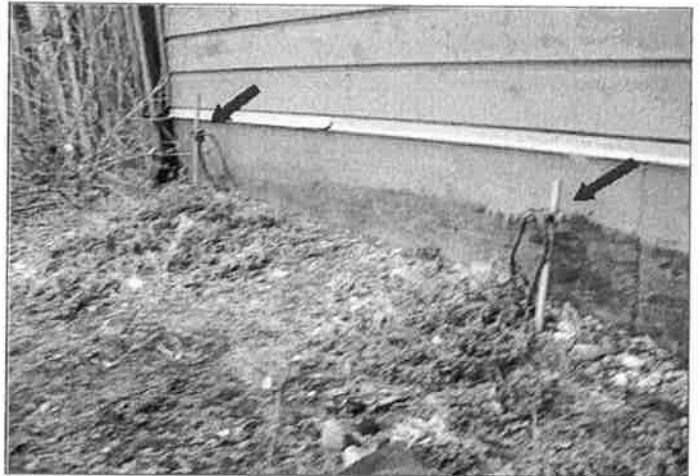
The main ground is connected to a grounding rod. The grounding appeared to be proper at the time of inspection.

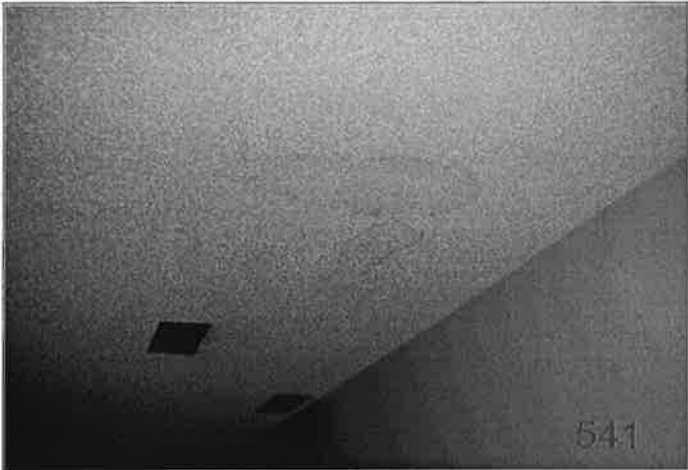
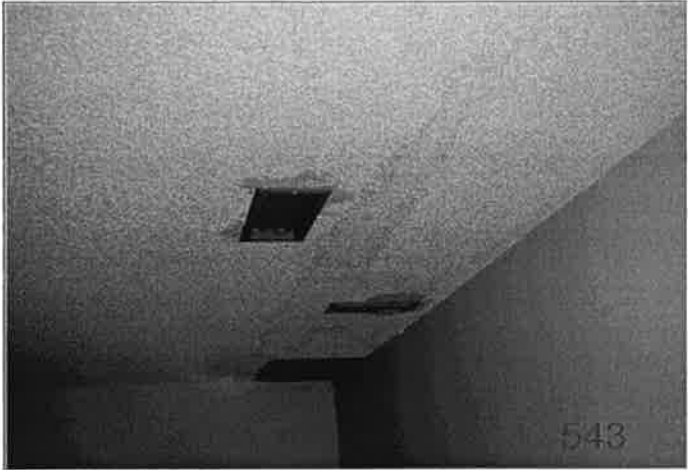
There are water stains on the ceiling below the kitchens in units 541 and 543. This would suggest there has been a plumbing leak from the kitchen pipes. Recommend further evaluation.

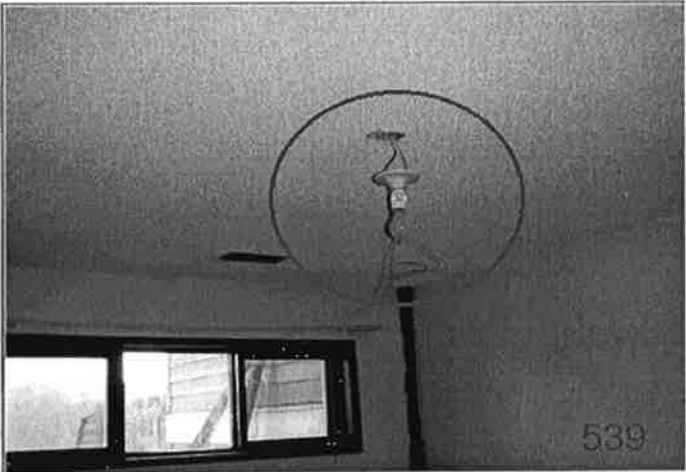
89) Lighting Conditions

NR There is a light fixture hanging by its wires in unit 539.

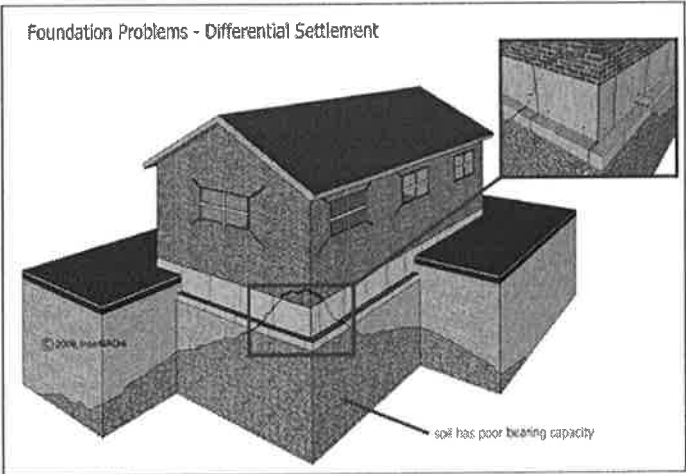
91) Foundation Condition      **NR**      The foundation of this building is unstable. There is numerous signs of differential settlement. This means the building has sank at uneven rates causing structural shifting and damage. The signs show the building has sank to the rear and to the right (south and west). Soil depressions at the rear of the building suggest that the ground is unstable. Due to the conditions observed I do not believe the building is salvageable. Recommend further evaluation from a structural engineer and / or foundation specialist. The building may be salvageable but the costs would most likely be beyond its worth.

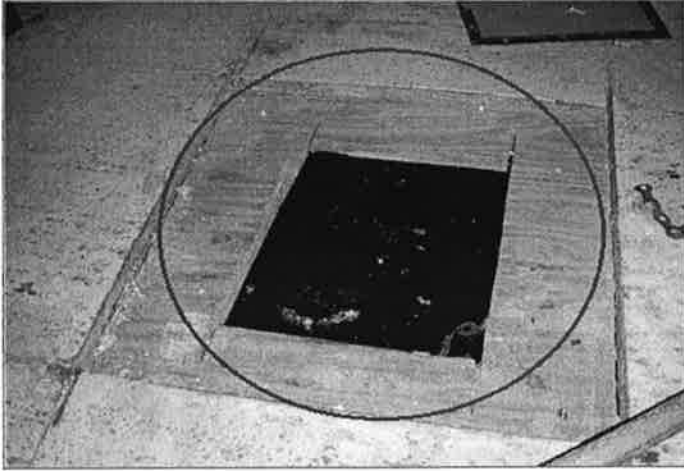
The crawlspace in unit 547 is filled with water. This condition may be fixed by adding perimeter drains but judging by the settlement observed it may not help the buildings overall condition.
